## COMMITTEE MEETING MINUTES: 10 September 2020

### Site Specific Hazard Materials Survey (HMS – Ceiling Space)

## **NEWCASTLE BRIDGE CLUB**

This report presents the findings of a Hazardous Material Survey (HMS) carried on the Newcastle Bridge Club Hall located at 12 Young Drive Broadmeadow.

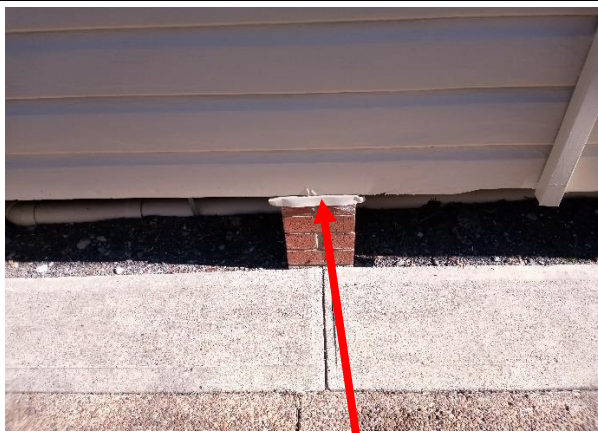
**Photo 1**

| SUMMARY OF RESULTS | | | | | | | | | | |
|---|---|---|---|---|---|---|---|---|---|---|
| | - | Foundations | Pier Packers | Possible FFCS | Deemed to Contain asbestos | Non-Friable | Good | Low | if to be impacted on from renovations, maintenance and/or demolition have removed, | - |

Pier Packers Deemed to be FFCS and contain Asbestos.

- Areas and/or materials that were inaccessible or not available to sample at time of inspection are deemed to contain asbestos.
- Asbestos containing material in bonded state if it is to be impacted upon in the future for renovations, Maintenance and/or demolition then it should be removed by a “B” licensed asbestos removalist under bonded asbestos controlled conditions.

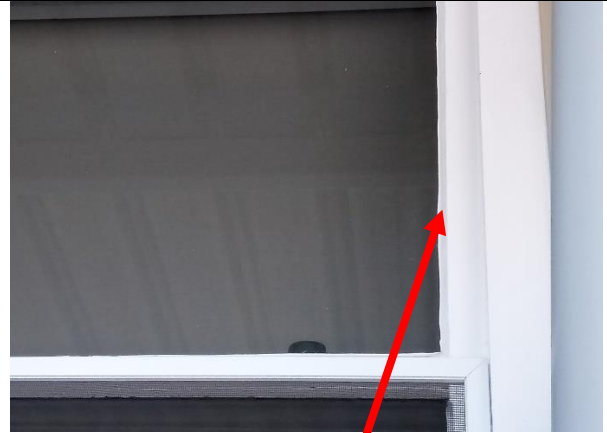
**Photo 2**

Window Putty Deemed to contain Asbestos.

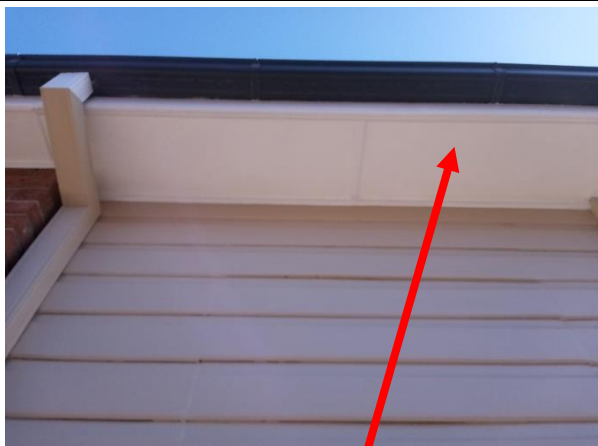
**Photo 3**

Eave liners Deemed to be FFCS and contain Asbestos.

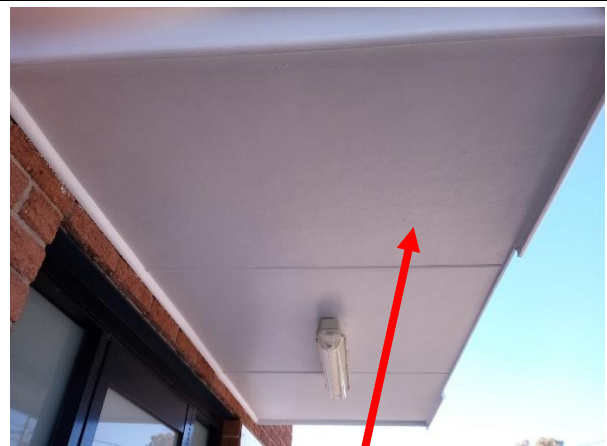
**Photo 4**

Front Awning liner Deemed to be FFCS and contain Asbestos.

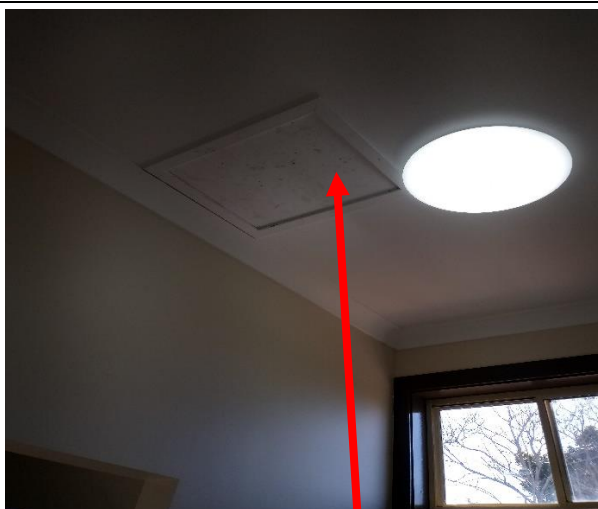
**Photo 5**

Manhole cover FFCS and Deemed to contain Asbestos

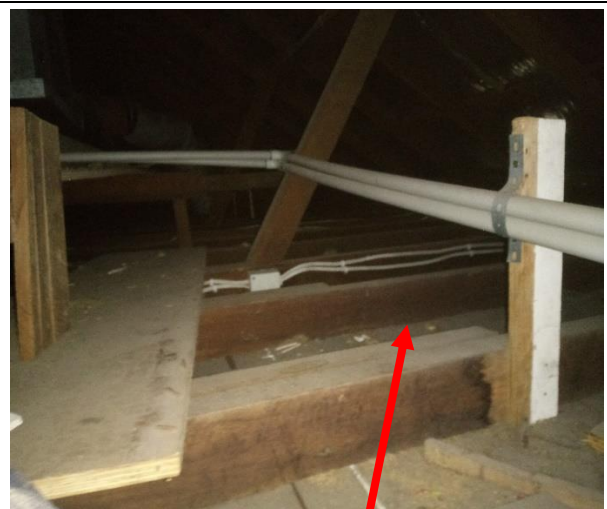
**Photo 6**

| Photo No | Sample No | Location / Room | Surface Description | Material Description | Material Status | Friable/ Non-Friable | Condition | Risk Rating | Recommendations/Comments | Qty (m <sup>2</sup> ) |
|---|---|---|---|---|---|---|---|---|---|---|
| | E74299 & E74300 | Back section of hall ceiling Space, including over kitchen and lady's toilet | Plaster | Ceiling space contain deleterious waste | Samples of Debris contains Chrysotile asbestos | Non-Friable | Poor | High | Under Best Practice Have ceiling space cleaned out under Friable conditions | - |

Pieces of debris found in rear ceiling space proved to contain Asbestos E74299 & E74300.

- As stated in the summary of Hazardous Material Register the ceiling space needs to be cleaned of asbestos debris and dust containing asbestos debris, due to the nature of this work it is strongly recommended Under Best Practices that the ceiling be Cleaned of asbestos under Friable Conditions using a “A” licenced asbestos removalist.

- A visual clearance as well as swab testing must be carried out after the removal of asbestos debris and dust from the rear ceiling space.

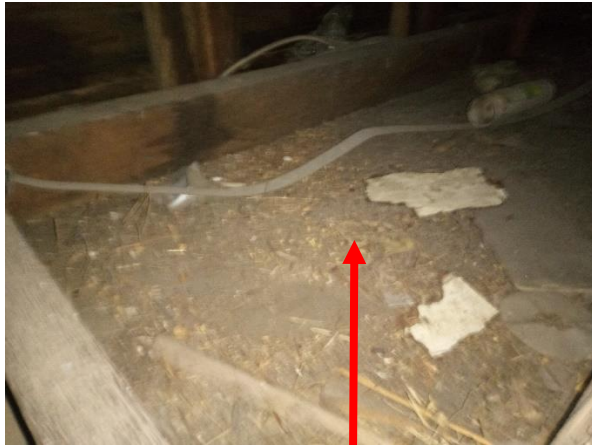
**Photo 7**

| Photo No | Sample No | Location / Room | Surface Description | Material Description | Material Status | Friable/ Non-Friable | Condition | Risk Rating | Recommendations/Comments | Qty (m <sup>2</sup> ) |
|---|---|---|---|---|---|---|---|---|---|---|
| | E74301 | Back section of hall ceiling Space, including over kitchen and lady's toilet | Plaster | Dust within ceiling space | Dust Sample contains Chrysotile Asbestos Bonded Clusters | Non-Friable | Poor | High | Under Best Practice Have ceiling space cleaned out under Friable conditions | - |

Dust Swab from Rear Ceiling Space proved to contain Asbestos E74301

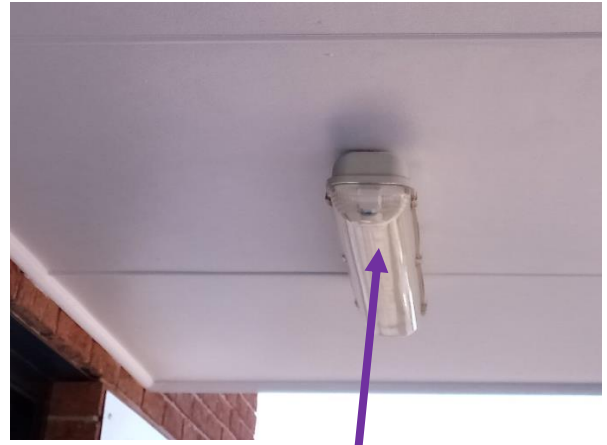
**Photo 8**

Fluorescent light fittings installed pre-1980 may contain PCB filled capacitors. If such capacitors were intact, good condition and not leaking, then they would be considered as low risk.

| Photo No | Sample No | Location / Room | Surface Description | Material Description | Material Status | Friable/ Non-Friable | Condition | Risk Rating | Recommendations/Comments | Qty (m <sup>2</sup> ) |
|---|---|---|---|---|---|---|---|---|---|---|
| | - | Throughout Hall | Fluro Lights internal capacitor | May Contain Enclosed PBC | PBC is an extremely high Carcinogenic | N/A | No visual sign of leakage | If Present High | Have lights checked by Licenced electrician if brownish liquid starts to show, <b>DO NOT TOUCH seek help in correct clean up procedure</b> | - |

Fluro light fittings throughout building may contain PCB due to age of fittings.
